#### **VALDEZ NEW BOAT HARBOR PHASE 1 - UPLANDS**

CONSTRUCTION PROGRESS REPORT No. 17 AUGUST 24, 2015 - AUGUST 30, 2015

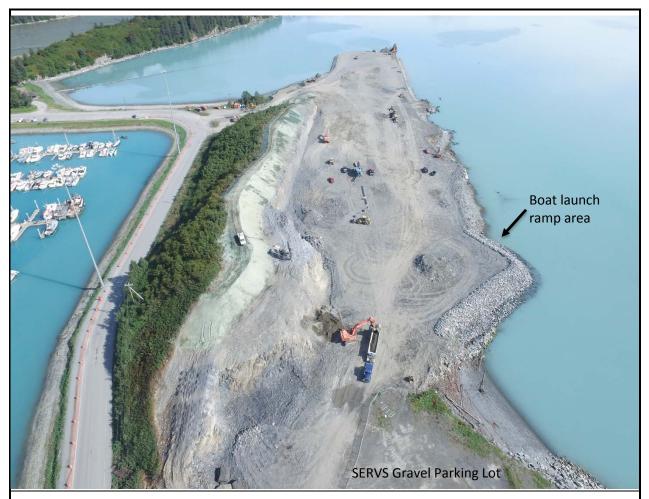
Most of the overburden has been excavated, the upper slope shaped, and topsoil applied. Bedrock has been shot and excavated on east part of the hill (top half of photo). New west access will be lower left. (image by J. Talbott, COV)

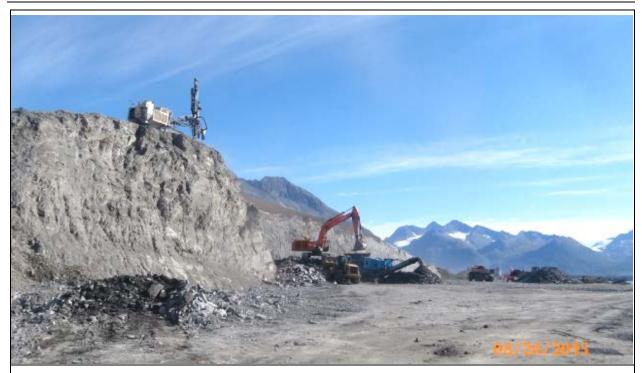
View East. Drilling, shooting and excavating bedrock in progress at NW corner of site. Excavator (center) is feeding crusher with shot rock. Right side shows the site has been excavated and fine-graded 2' below final grade/pavement.

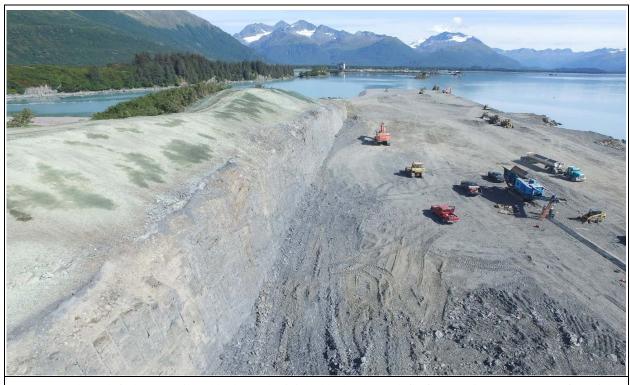
Upper 2:1 slope (left) has topsoil and hydroseed. Finished bedrock cut (left of center) is 1H:4V. Most of the right side has been excavated and rough-graded 2' below finished surface. East fill is at far end. (J. Talbott, COV)
